A Detailed Conservation Report of a Heavily Retouched Painting from the Otto Valstad Collection

Masteroppgave in Malerikonservering

Institute for arkeologi, konservering og historie

Virgin and child with St Elizabeth and infant St John the Baptist, in a landscape – Asker Museum

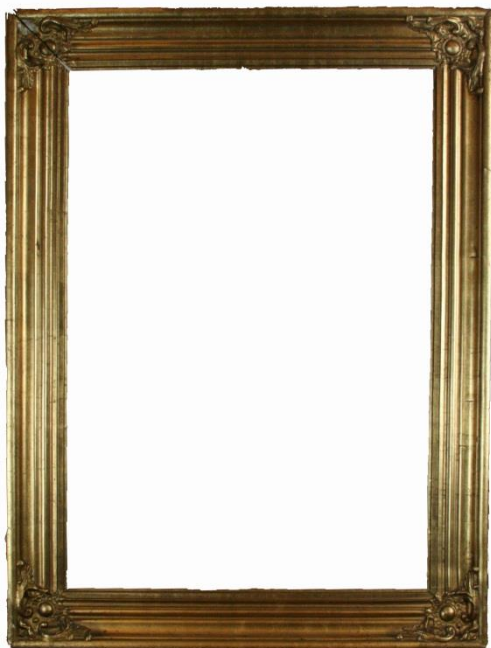
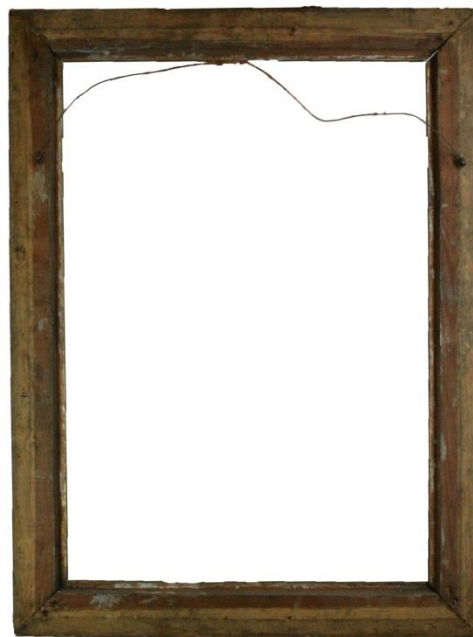
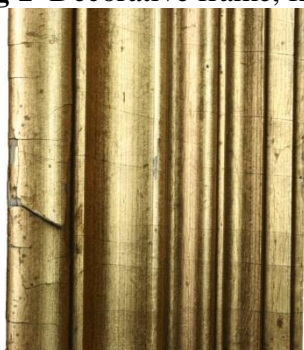
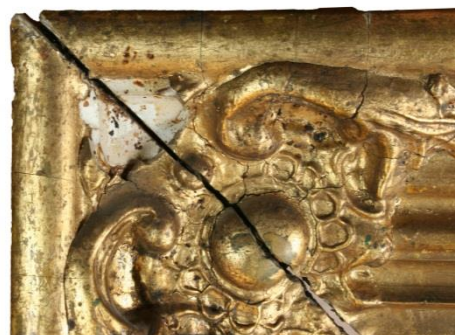
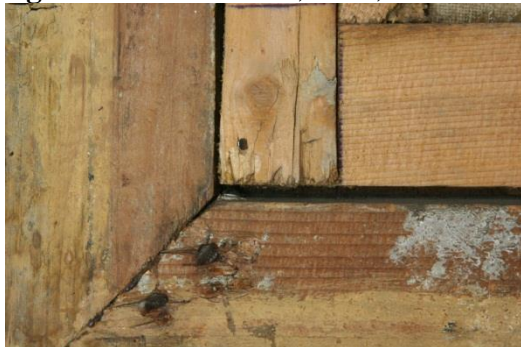
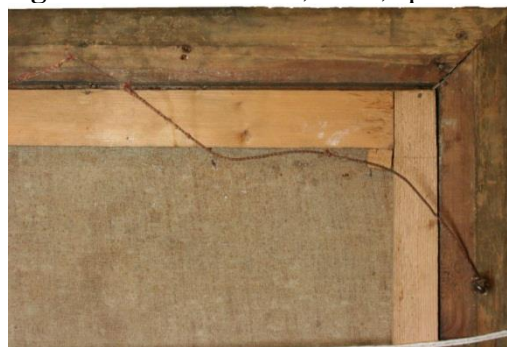
With regards to its condition only visual investigations were undertaken. No additional analysis was deemed necessary as its condition was considered stable.

Img 1 Decorative frame, front

Img 2 Decorative frame, back

Img 3 Decorative frame, front, mid-section

Img 4 Decorative frame, front, split corner

Img 5 Decorative frame, back, lower corner

Img 6 Decorative frame, back, upper corner

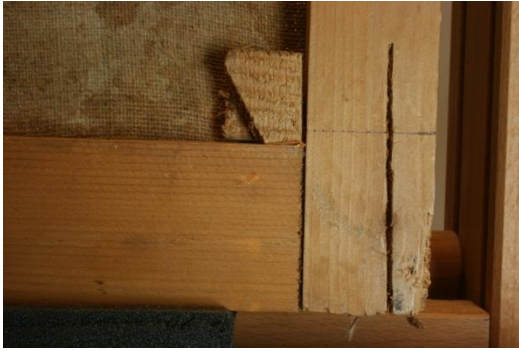
Img 7 Secondary stretcher, ball point pen marks and

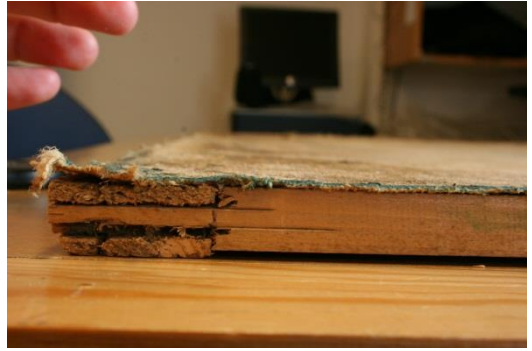
Img 8 Secondary stretcher joints

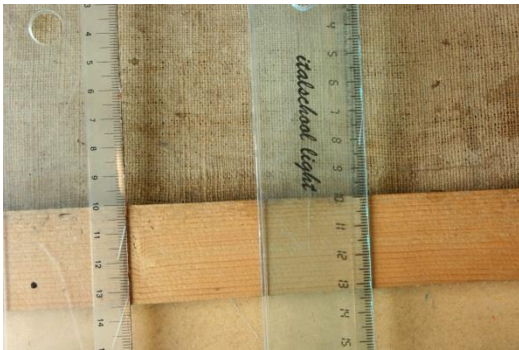
Img 9 Secondary stretcher, uneven stretcher plank

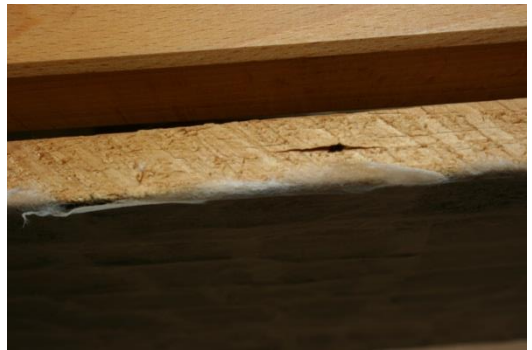
Img 10 secondary stretcher, circular saw pattern

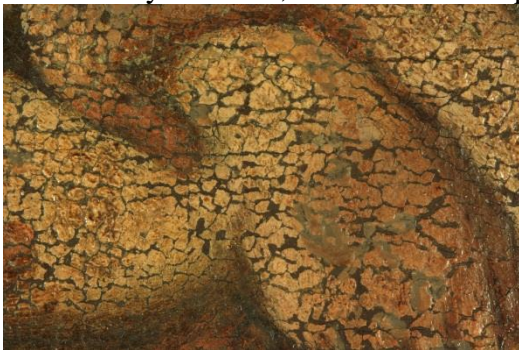
Img 11 Drying craquelure in the skin tones

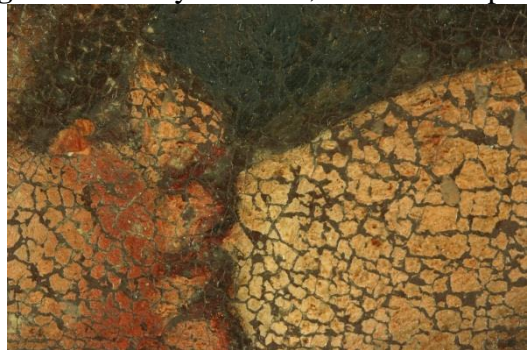
Img 12 Drying Craquelure in the skin tones

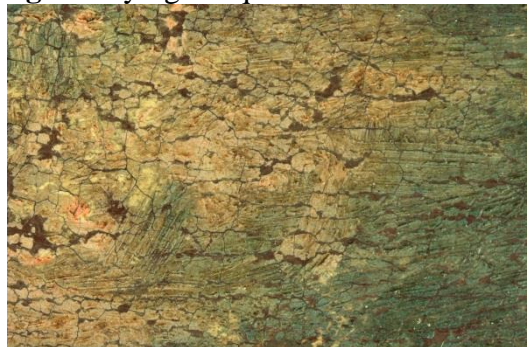
Img 14 Upper landscape, visible ground in the lighter areas

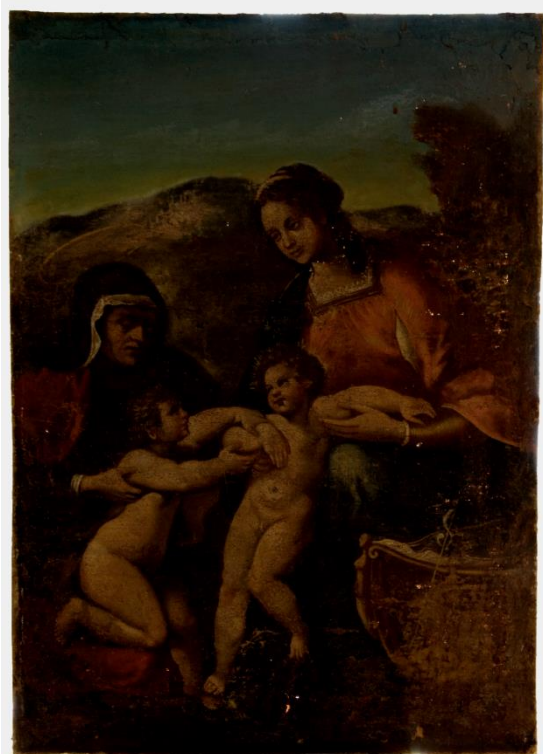
Img 23 Transillumination image, prior to treatment

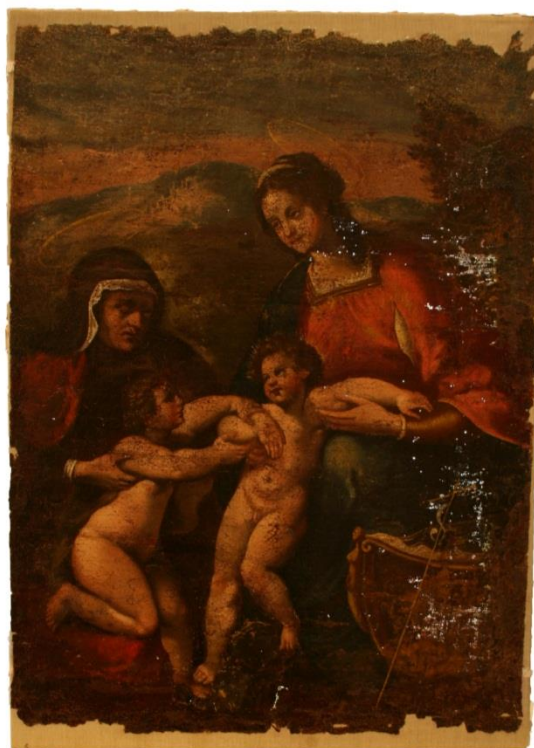
Img 24 Transillumination image, after treatment

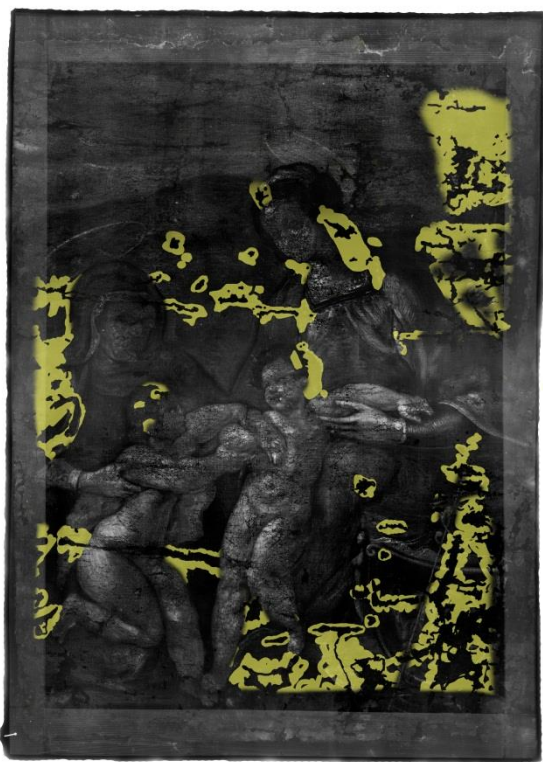
Img 34 Overpaint on original, after 2013/2014 treatment

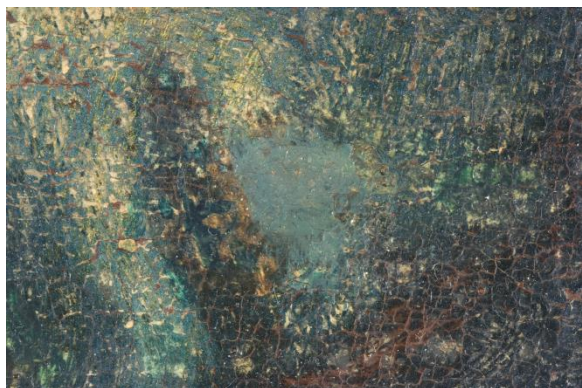
Img 46 Visible retouches and overpaint 1

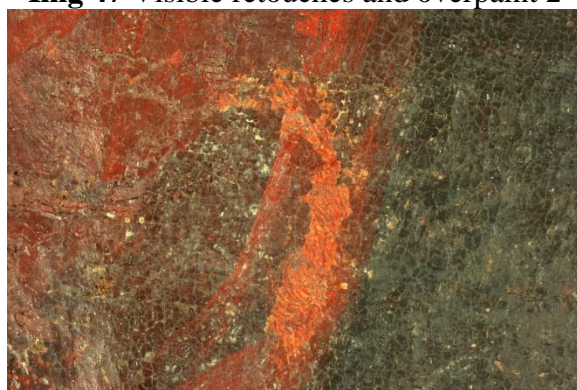
Img 49 Retouches and visible filler material 2

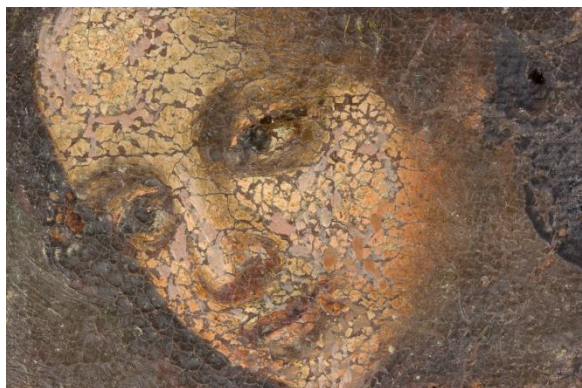
Img 68 Prior to varnish and secondary paint removal

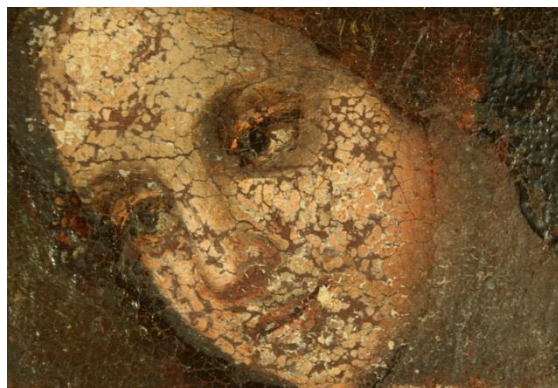
Img 68 After removal of varnish and secondary paint

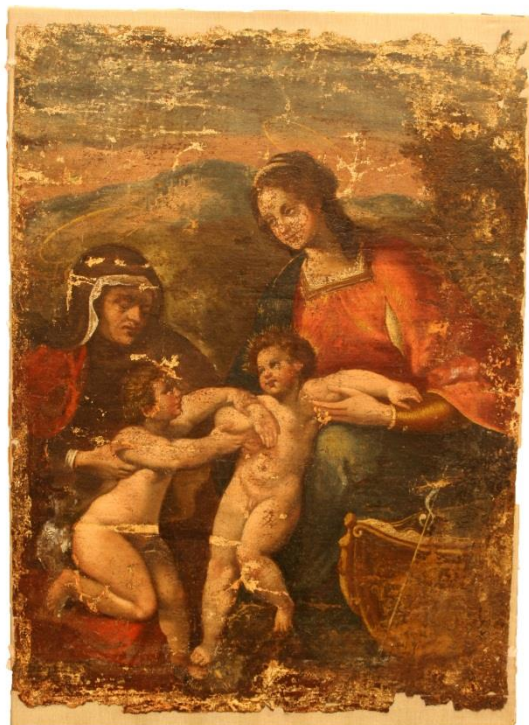
Img 74 The selectively cleaned painting, performed in the 2013/2014 treatment

In the 2013/2014 treatment, the painting was selectively cleaned (Appendix 1 Fig 1.3). This choice was based on the stability of the varnish layer, combined with lack of time and a desire to preserve some of the paintings history. It became clear through investigations of overpaint and retouches, that treatment involving the retouching of all the losses of this painting, after varnish removal would require a great deal of time. Also, since the varnish layers were not considered to be as visually disruptive to the paintings overall understanding, and distinctions between how much yellow is too much can be considered relative (Hansen-Bauer 1996:168), a selective cleaning was justified. The darkened varnish would aid in the identity of the artwork being as old as it once was, especially seeing that it hangs in a historic house among old things. Also, since this painting had been heavily retouched before, possibly by Otto Valstad himself, it was regarded that this painting would benefit in a selective cleaning in order to preserve its past. As an additional consideration was taken into account regarding the removability of the varnish with a lesser polar solvent (iso-propanol), therefore it could be concluded that the varnish was not as heavily oxidized as once thought. The painting is also hung in a very poorly lit area of the room, which reasonably concurred why oxidation is not happening as fast. Hedley (1990A:152) has discussed extensively the advantages and disadvantages concerning the aesthetics related to partial, selective and total cleaning of a painting. And, with reference to Hedley (1990A), the reasons argued for here are not gen-

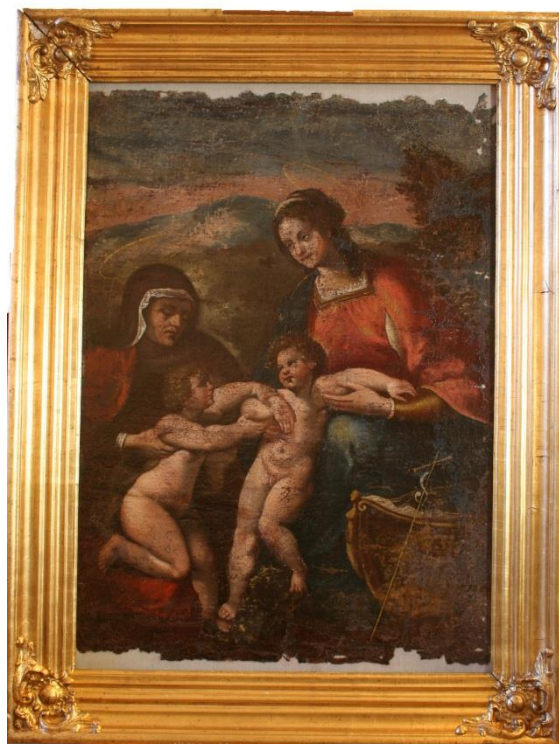
Img 75 Image after retouching mounted in its frame, notice the bare secondary canvas.

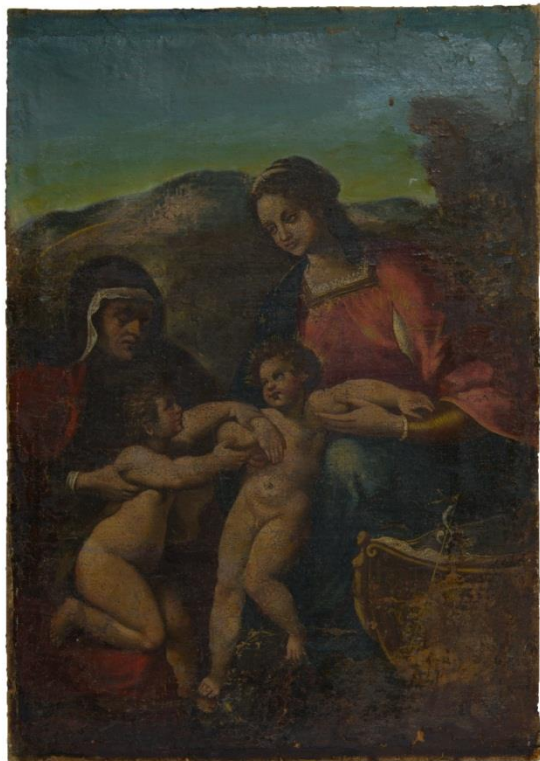
1. **COL⁸² (Fig 1.1):** The colored image was taken of the painting upon its arrival to the atelier at the University of Oslo, Conservation program. This colored image is illustrated as the paintings before picture and was taken in visible light.

Fig 1.1 Color image, prior to investigations and treatment

painting looked like prior to this 2013/2014 treatment may later prove to be significant (Appendix 1 Fig 1.1). This documentation was also important considering, the cleaning investigations regarding the intact layers of original paint found beneath the overpainted sky resulted in a clear difference in its portrayal (Imgs 64 & 65). Also, it was clearly observed in X-ray (Appendix 1 Fig 1.2) that the existence of intact original paint was present and that St. Mary's halo had been visibly painted over. Therefore, the removal of the overpainting proved to be more altering in its portrayal and understanding of the overall motif thereby considered ethically correct since it covered intact original paint (van de Goltz and Stoner 2012:499). Other secondary paint was also removed and considered accordingly, however, this painting was selectively cleaned in hopes to combat some of the ethical dilemmas regarding preservation of historical evidence of the paintings past.

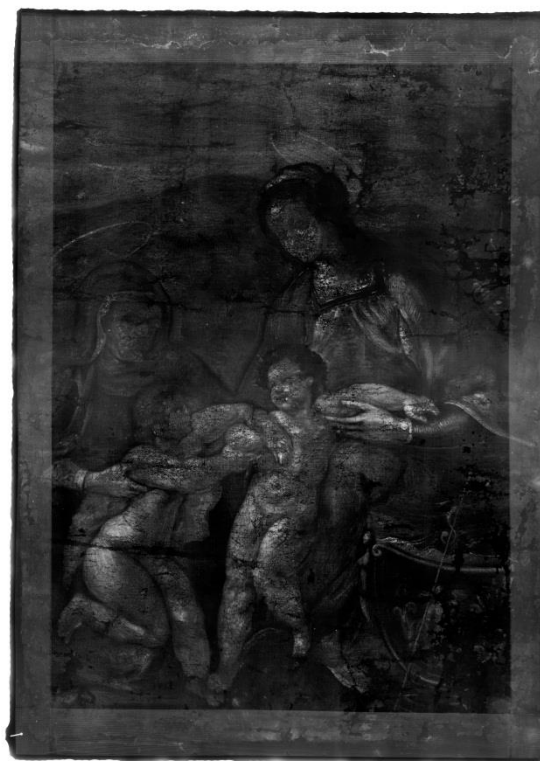
5. **X-RAY⁸⁶ (Fig 1.2):** X-radiographs short-wavelengths and high-energy penetrate all materials in a painting (Stuart 2007:78). X-radiographs provide information of certain pigments and attributes linked to a paintings support system since the x-ray absorption is heavily dependent on the atomic weight and density of the employed materials (Stuart 2007:79). X-ray can also provide regarding the identification of filler material as its density could be incongruent with its surroundings in the painting (Stuart 2007:79).

Fig 1.2 X-ray of the image, prior to investigations and treatment

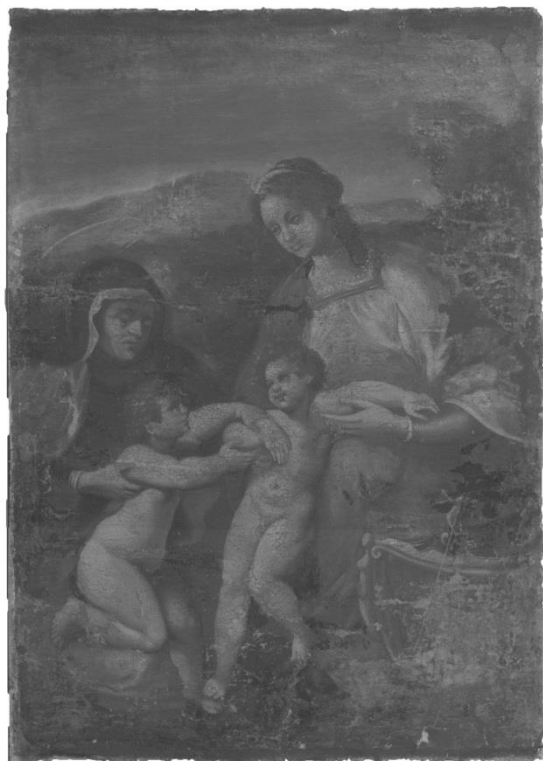
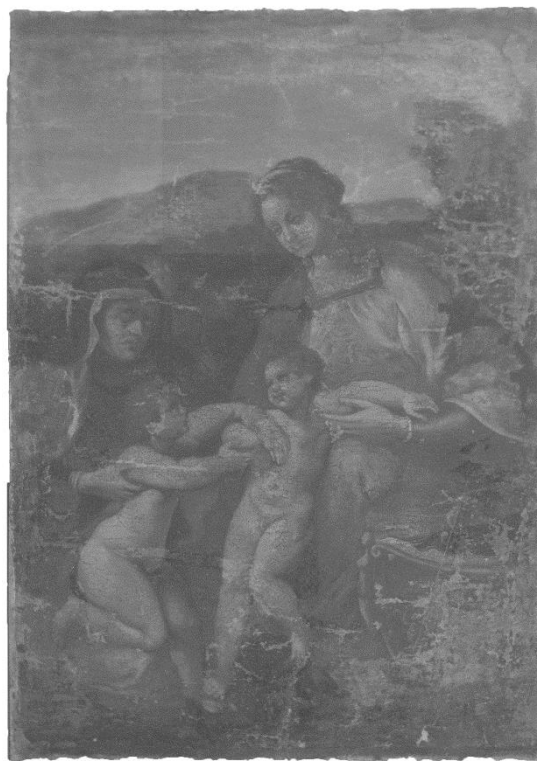
2. **IR⁸³ (Fig 1.5 & 1.6):** IR imaging was performed on the painting mainly to see if any eventual under-drawings were present. Infrared regions are of lower wavelengths than regular light (Newman 2000:171) and many pigments do not absorb as many IR rays making them transparent in these imaging modes. Transparent paint will therefore reveal underlying drawings that were created using pigments that absorb a lot more, like carbon black for instance (Matteini and Mazzeo 2009:51). However, since this painting is painted on a colored ground, it became clear that if an underdrawing was present, it would not be rendered visible through IR1 and IR2 since colored grounds have the potential of being made of materials that absorb just as much IR as the pigment used in the under-drawing (Matteini and Mazzeo 2009:51). Therefore, IR imaging had only the capability of aiding in the identification of secondary materials found in the painting.

Fig 1.5 IR-1 image, prior to the investigations and treatment

Fig 1.6 IR-2 image, prior to the investigations and treatment

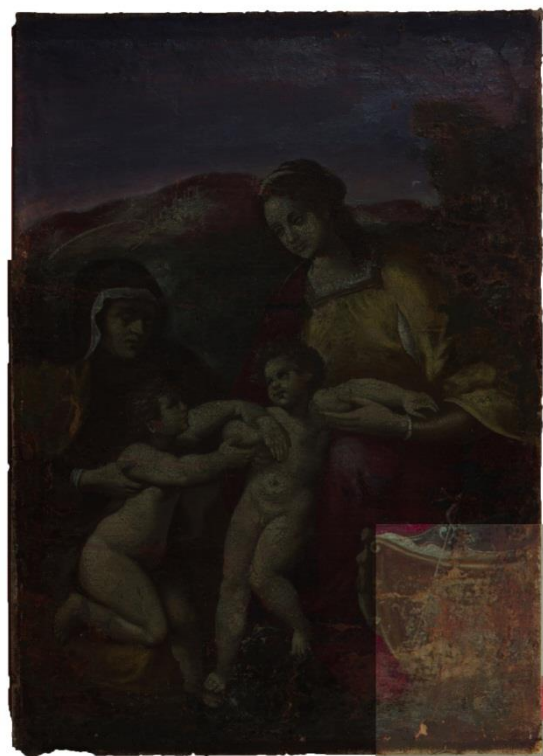
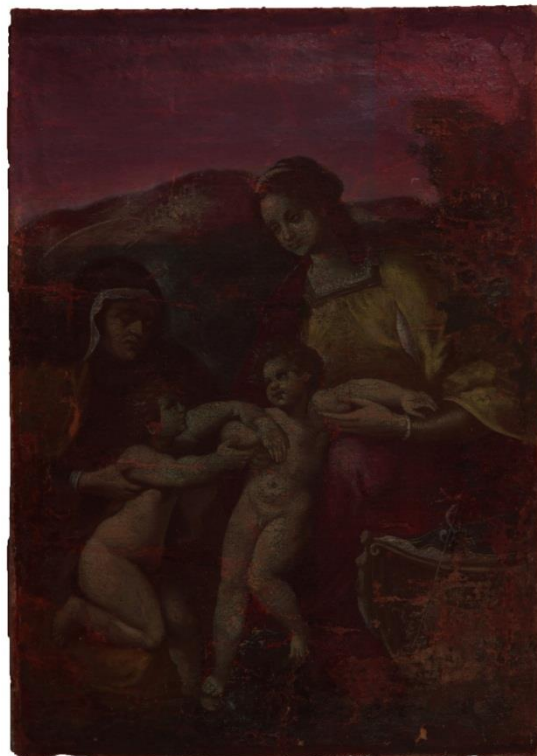
Through FCIR investigations (Appendix 1 Fig 1.7-1.8), this area emits a more purple hue. The blue and greens, provided by Moon (et al 1992) that transmits a reddish blue tone are suggested to be indigo and ultramarine. However, due to the high cost of importing and the long laborious process of extraction the

Fig 1.7 FCIR-1 image, prior to the investigations and treatment

Fig 1.8 FCIR-2 image, prior to the investigations and treatment

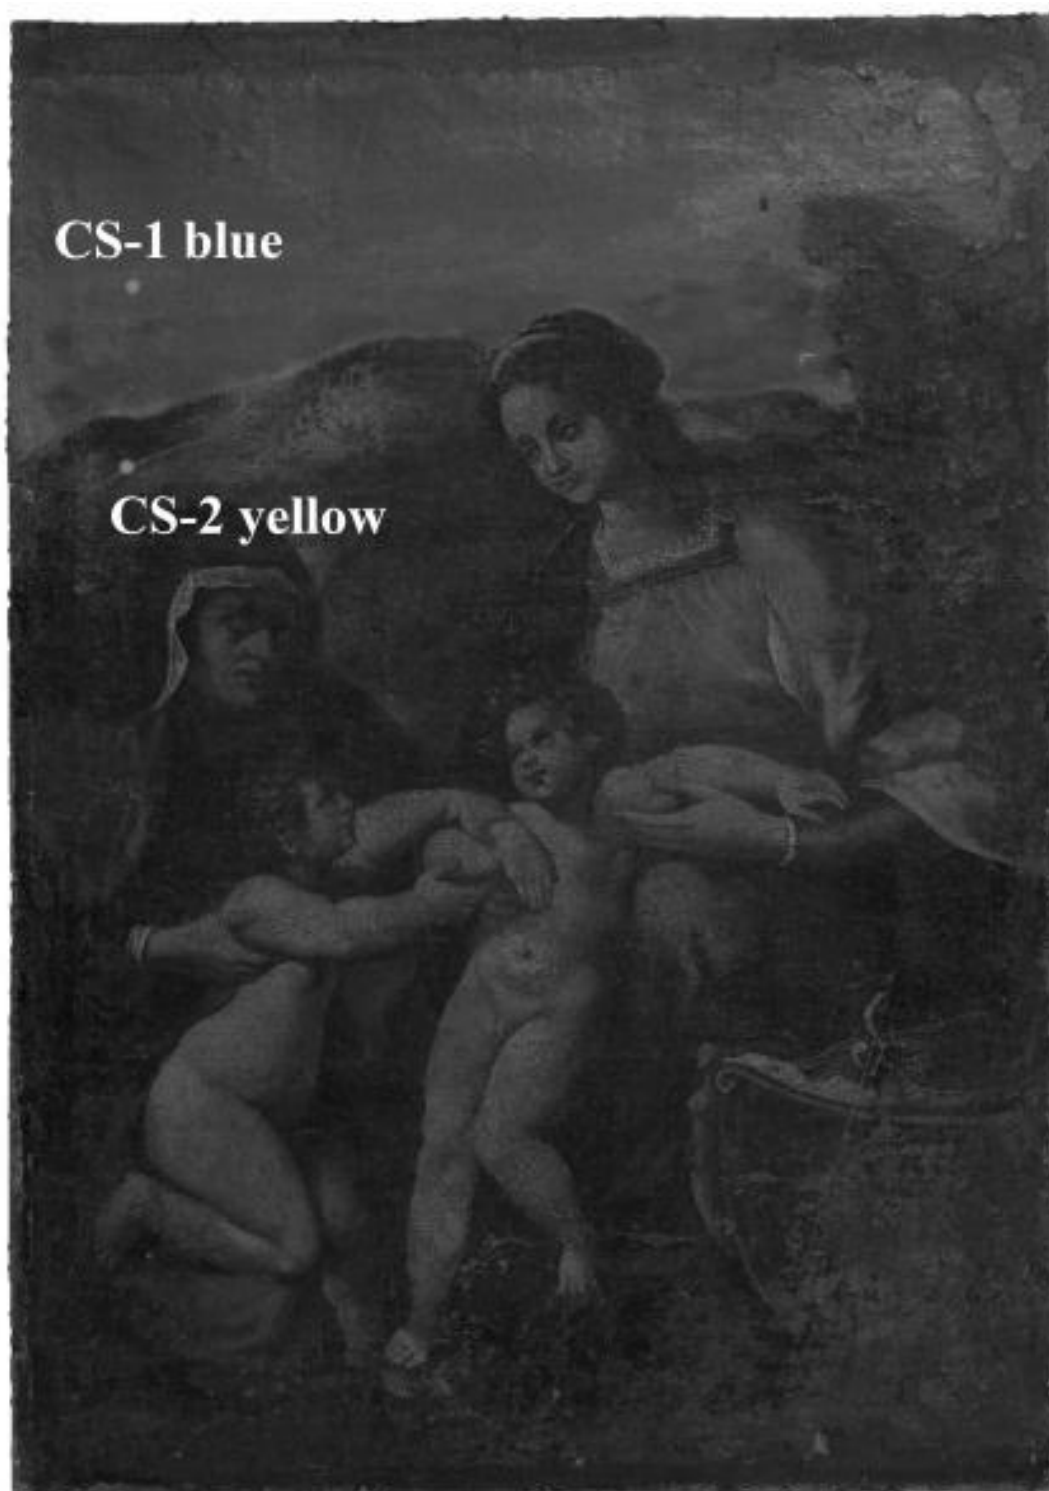
Fig 3.1 Location overview of extracted samples

As mentioned, two paint samples have been extracted from this painting. Their location can be seen, in the Fig 3.1. These paint samples are labeled as CS-1 blue and CS-2 yellow. These two samples were extracted in order to gain a clear understanding regarding the application technique of the painting while also gaining information regarding the components found in the ground, two original paint layers, and one secondary paint layer. These extractions also made it possible to visually examine the secondary varnishes located on the painting through optical microscopy.

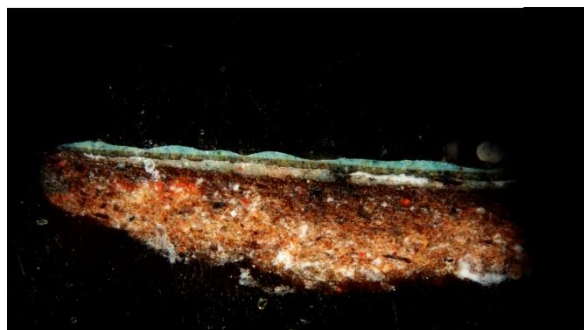
Yet, as you can see in optical microscopy image of the blue extracted sample (CS-1 blue) the original layer found beneath the overpainting has in some areas a blueish tint to it (Appendix 3 Fig 3.2). An attempt was therefore made to ensure a reading on one of the blue pigment particles found within the

Fig 3.2 CS-1 blue, transmitted light

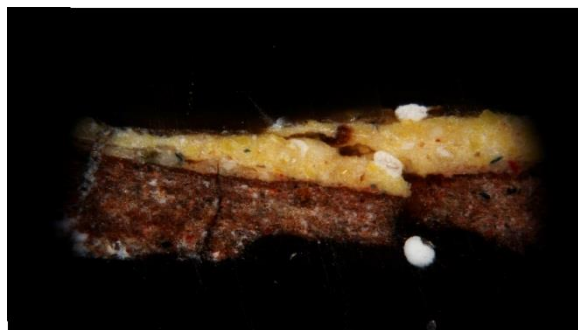
A piece of St. Elizabeth's halo was extracted from the painting (CS-2 yellow) and viewed under optical microscopy and analyzed using SEM-EDX (Appendix 3 Fig 3.3, 3.5, 3.7 & 3.9). The optical microscopy pictures clearly show that there are two layers of original paint found in the sample (one of the green upper landscape, referred to above, and one consisting of a yellow). The data retrieved from the SEM-EDX indicate that the yellow may have been painted with a lead-tin yellow³⁰, lead-antimonate yellow³¹ or lead-tin-antimony yellow³², since both Sn and Sb were found in the analysis of this layer (Appendix 3 Fig 3.16-3.18). There has been much debate regarding these types of yellow pigments since it wasn't

Fig 3.3 CS-2 yellow, transmitted light

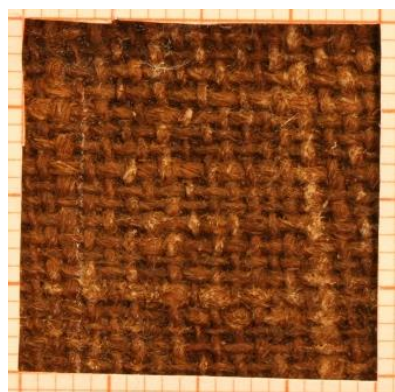
Fig 4.19 Original canvas weave structure

Measures: (in cm)	H: 65-67 cm / L: 49-49.5 cm / D: 0.1 cm (no tacking margins are available) Woven fabric
Weave structure:	Plain tabby weave. No selvedge is available. Thus, warp or weft cannot be identified.
Fiber analysis:	<i>Direction of twisting of yarn:</i> H: Z / V: Z, <i>Direction of twist test:</i> Counter Clockwise <i>Fibre type:</i> Hemp
	<i>Analysis method:</i> Visual, stereomicroscopy (10-50x), optical microscopy (10x-63x), sampling, folding test, pH test, and twist test

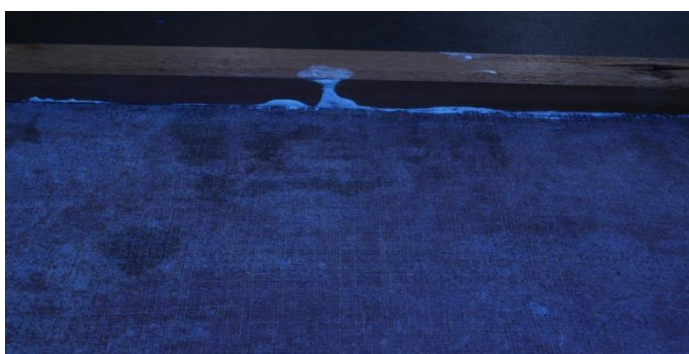
This glue employed to attach the painting to the stretcher can be observed under visible and ultraviolet (UV) illumination (Appendix 6 Fig 6.1-6.2). Under visible light this glue has no colour and is transparent, while under UV light this glue fluoresces a strong white, which combined with chemical spot tests³⁵, suggest that the glue is proteinaceous.

In the image to the right it was clearly visible where the adhesive was located as it fluoresced strongly in ultraviolet illumination. The samples used for chemical testing were extracted in the paintings lower left hand corner, using a scalpel.

Fig 6.1 The white fluorescence of the Stretcher glue under UV illumination

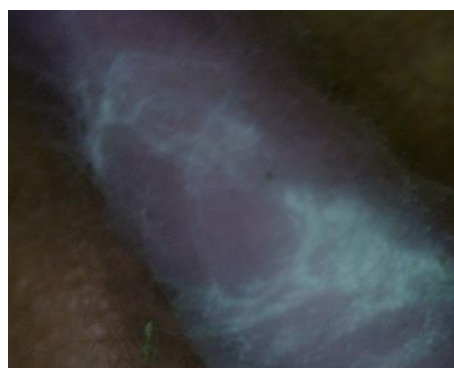
Fig 6.2 A water cotton swab of the adhesive, illustration that it was also soluble in water

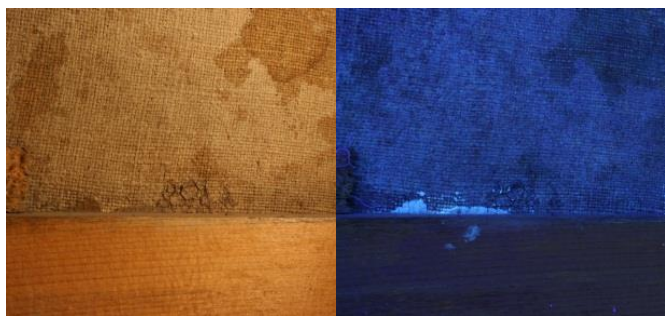
Fig 6.3 Extraction site of the stretcher glue. Glue in natural visible light and in ultraviolet illumination

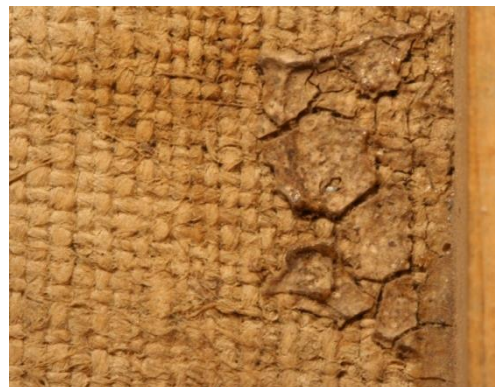
Fig 7.1 – extraction site

Unlike the stretcher glue, the glue used in the lining does not fluoresce as strongly under UV. Visually it was observed through crusty blotches located on the backside of the painting (Appendix 7 Fig 7.1-7.2). Chemical spot tests³⁷ for proteins and starch performed on the glue suggest that it was not proteinaceous, but does however suggest a cereal based glue (Appendix 7 Fig 7.3-7.5). Glue linings with using starch are well known to have been used in lining of paintings (Reifsnnyder 2012:416), therefore this is likely the glue used in this lining.

It was clear that throughout the entire backside of the secondary canvas there was another crusty substance. In the two images to the right (one in visible light and one in ultraviolet light), it is noticeable that this crusty substance does not fluoresce as intensely as the adhesive used to attach the stretcher to the canvas.

Solubility tests and chemical tests for protein and starch were performed on extracted samples of this crusty glue. The results indicated that this glue was soluble in water, was not proteinase, contained starch and had a similar Infrared spectroscopy graph for most vegetable glues. Through these results it was clear that this substance was the glue used in the glue lining, and was most likely a starch glue.
